## CORROSION OF DOMESTIC OIL TANKS

# CORROSION OF DOMESTIC OIL TANKS

By: William Moody, P. Eng.
Moody Engineering Consultants
Dartmouth, Nova Scotia

February 2000

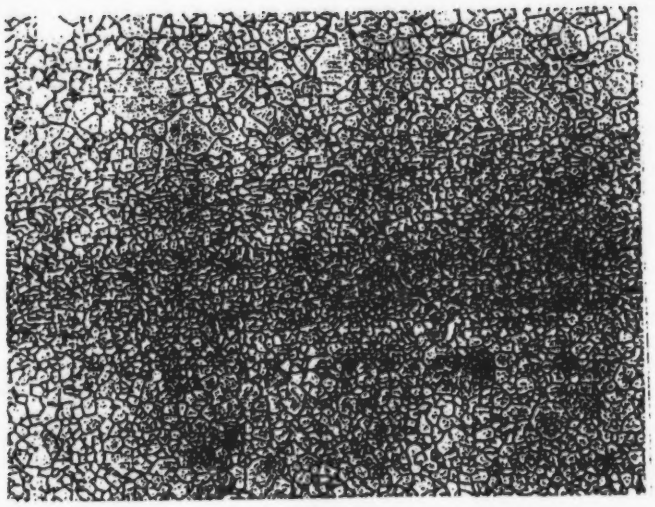
**Figure 1: Ferritic Grain Structure in Older Steel Oil Tank 100X**

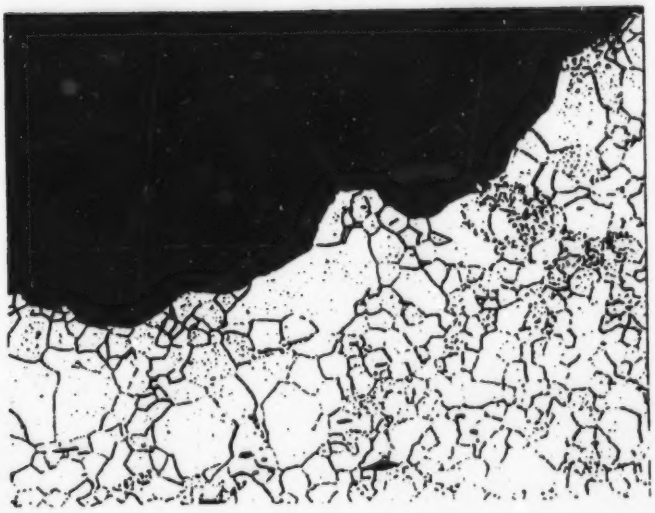
**Figure 2: Pitting Action Initiated at Inner Surface of Oil Tank 200X**

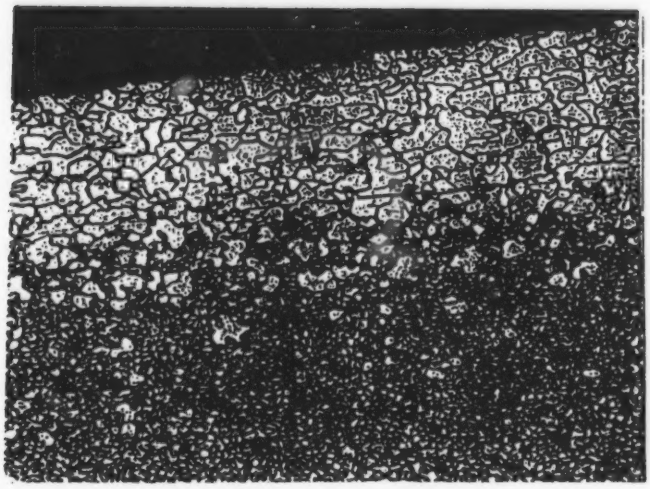
The shell thickness of the one old tank measured was greater than the new tank (2.1mm compared to 1.8mm). This is likely due to modifications in steel specifications over the years, for instance changing from thickness gauge to nominal metric measurements. It is interesting to note that the new tank "holed through" in less than two years. To withstand this corrosion rate (1 mm per year) for thirty years, the steel of the tank shell would have to have been 30mm thick. On the other hand the apparent corrosion rate for the old tank based on measured pit depths, is something less than .03 mm per year. The new tank would have lasted 60 years at this corrosion rate. It is obvious that thicker steel is not the answer to the corrosion problem. As the chemical and mechanical properties of the steel in the new and old tanks are similar there must be some other reason for the accelerated corrosion found in the new tank.

**Figure 3: Ferritic Grain Structure in Newer Steel Oil Tank 100X**

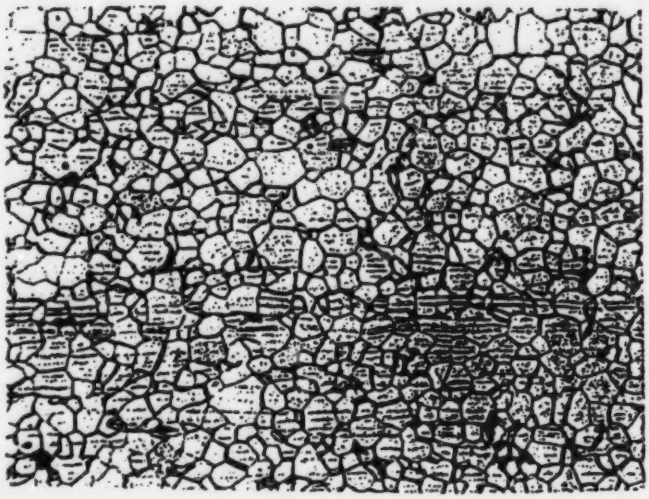
**Figure 1: Ferritic Grain Structure in Steel Sample B7 at 200X**

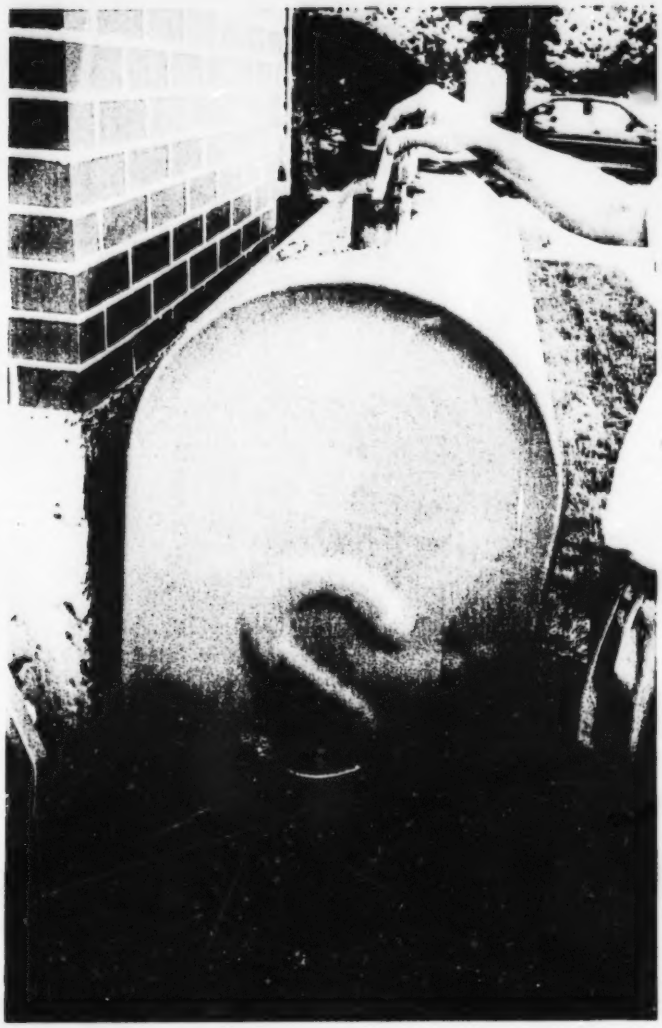
As noted in the last item above, included as part of the inspection was an investigation to determine the presence of water in a tank. The test could be completed only if there was easy access to the interior of the tank through an existing opening and consisted of inserting a dipstick through this opening. Water indicating paste (alkanolamine a dye, in clay as manufactured by Kolor Kut Products, Houston, TX) was applied to the end of the dipstick. If present, water being heavier than oil, sits on the bottom of the tank and is detected by a colour change in the paste. Eight such tests were performed and water was recorded in three instances. (See Figure 1)

**Figure 1 – Test using "Water Finding" paste**

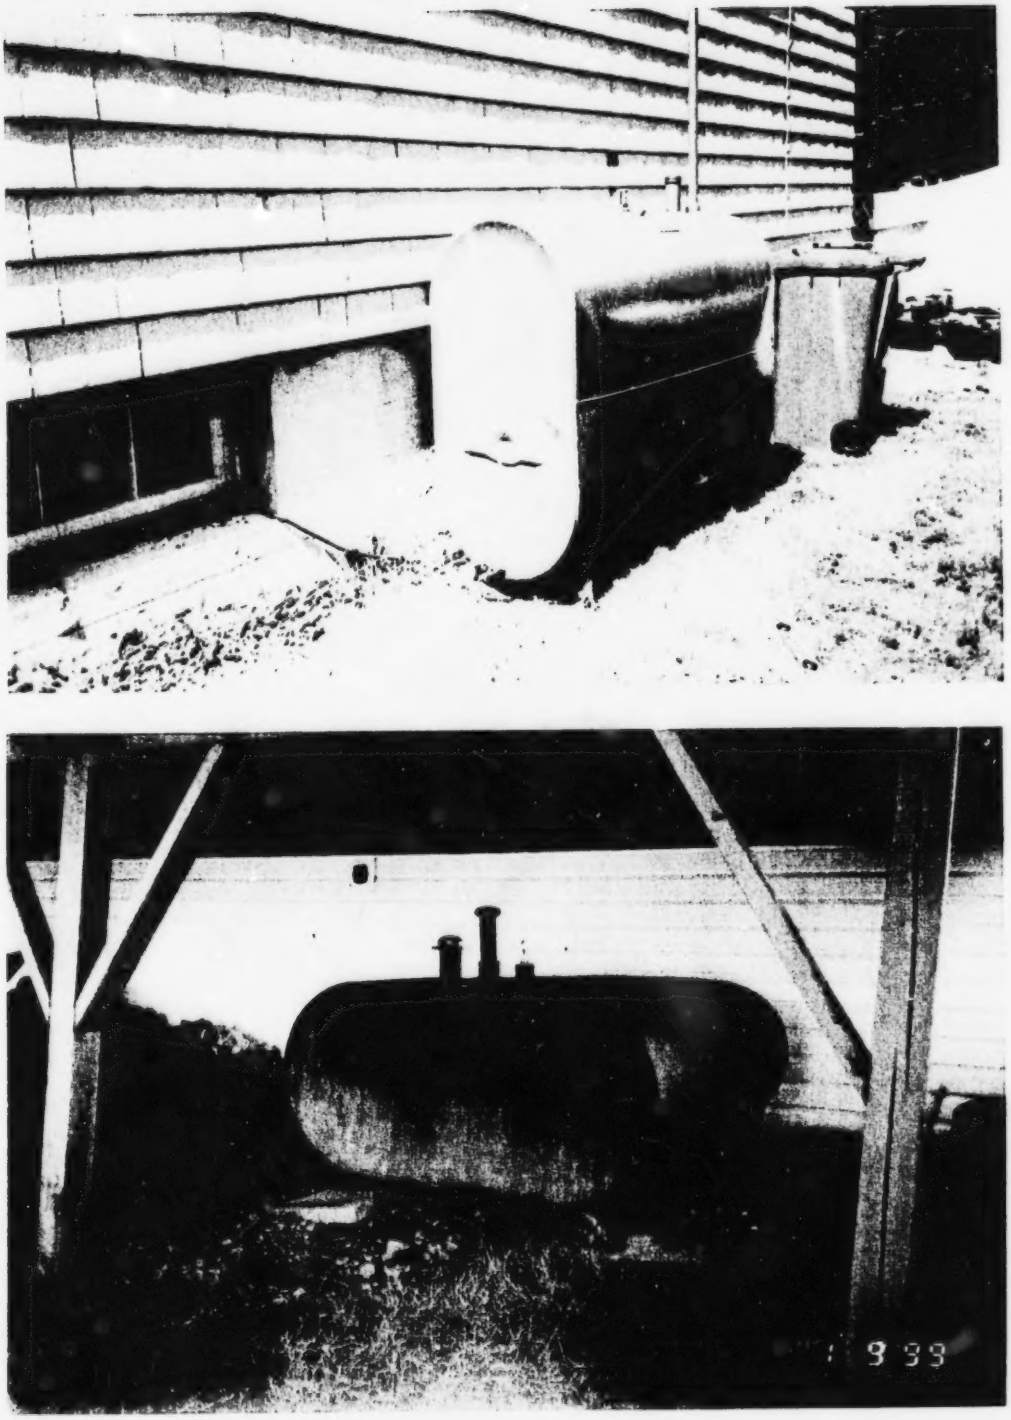
**Figure 2 – Typical outdoor tank installations**

Typical tank installations, inside and outside the home, are shown in the accompanying photographs (Figures 2 and 3).
